**National Highway
Traffic Safety
Administration**

Case Vehicle (A): 1999 Ford

Type: Crown Victoria (police interceptor), 4-door sedan

Vehicle (B): 1987 Buick

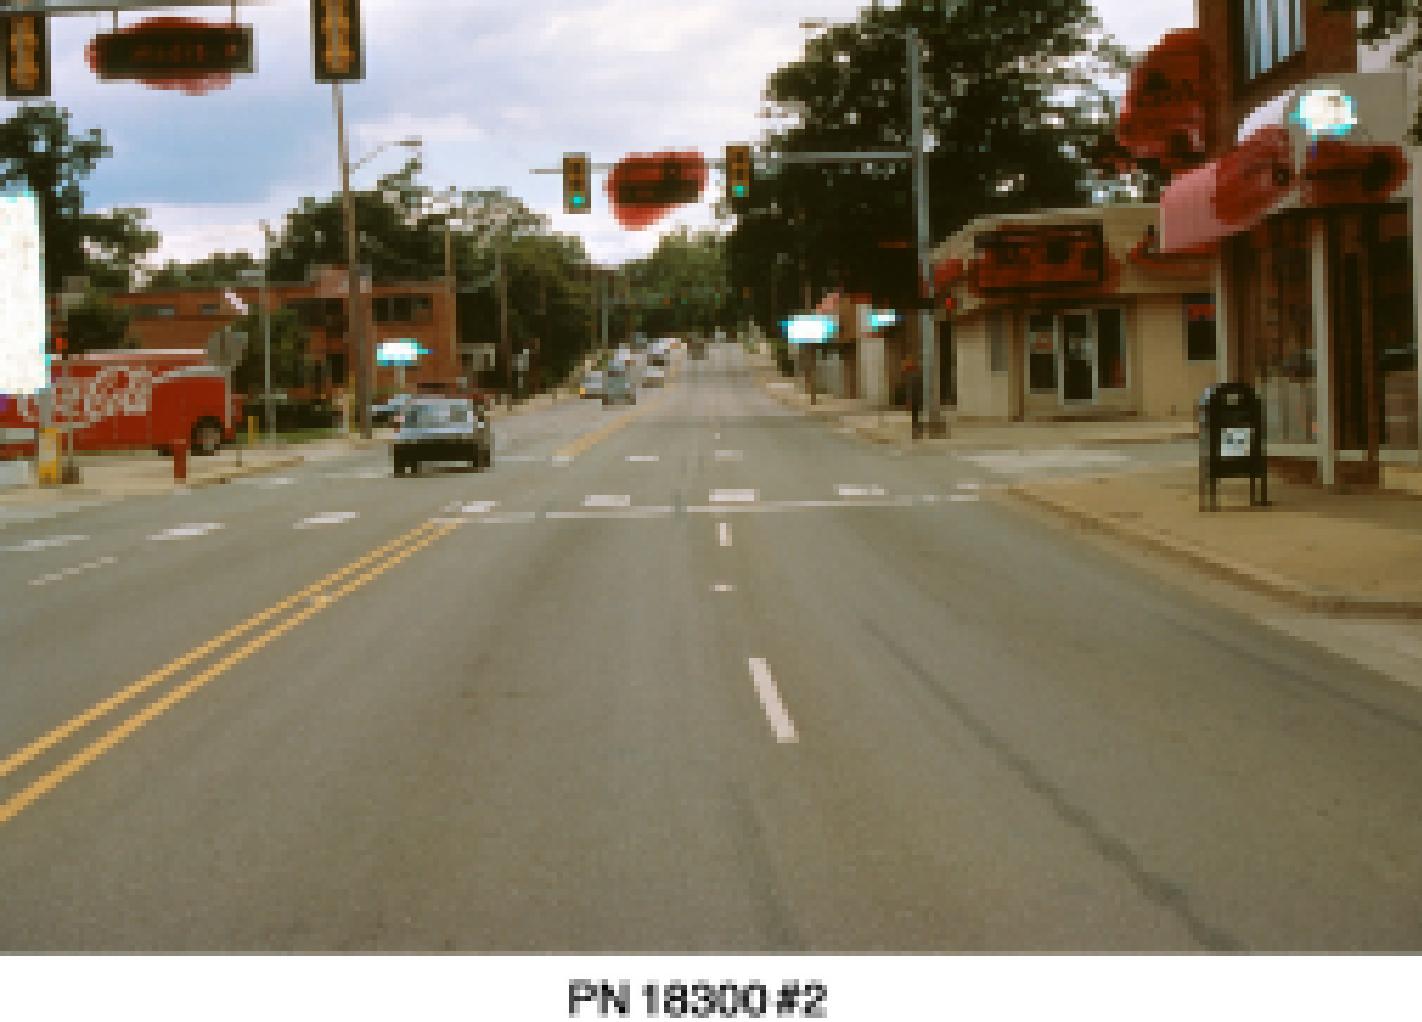
PH 18300 #1

(Slides 1, 2) On a clear, dry day, case vehicle (A) was traveling south in the right lane of a 4-lane asphalt road in an urban area at a driver-estimated speed of 40 kph (25 mph). Vehicle (B) was stopped facing north on the four-lane roadway at an intersection, and the driver was waiting to make a left turn onto the intersecting roadway. As case vehicle (A) proceeded into the intersection, vehicle (B) began making a left turn to travel west on the intersecting road. The driver of case vehicle (A) applied the brakes, but was unable to avoid striking the right side of vehicle (B) with its front. After the impact, vehicle (B) rotated clockwise and struck the left side of vehicle (X), which was stopped at the intersection facing east.

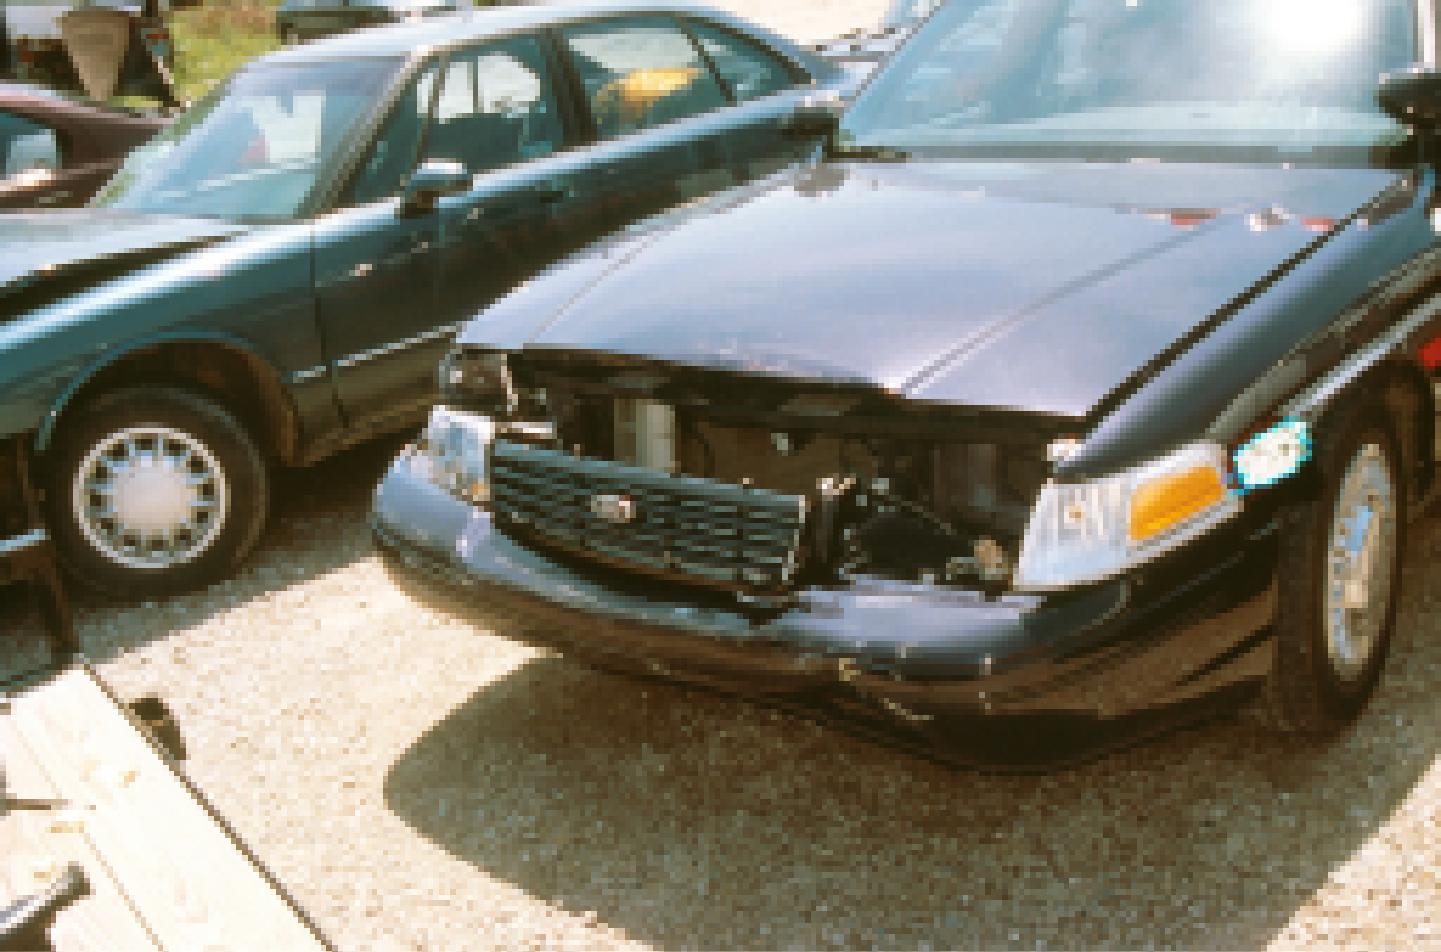
PN 18300-#16

(Slide 16) The damage to case vehicle (A) extended across the entire front. (Slides 17, 18) The bumper was crushed, both headlights were displaced and the left headlight glass was broken. The grille was damaged and the hood was dented. (Slide 19) There was no damage to the hood latch or hood hinges, although the rear edge of the hood was slightly elevated. In addition, there was no damage to the windshield. (Slide 20) There was no other frontal damage.

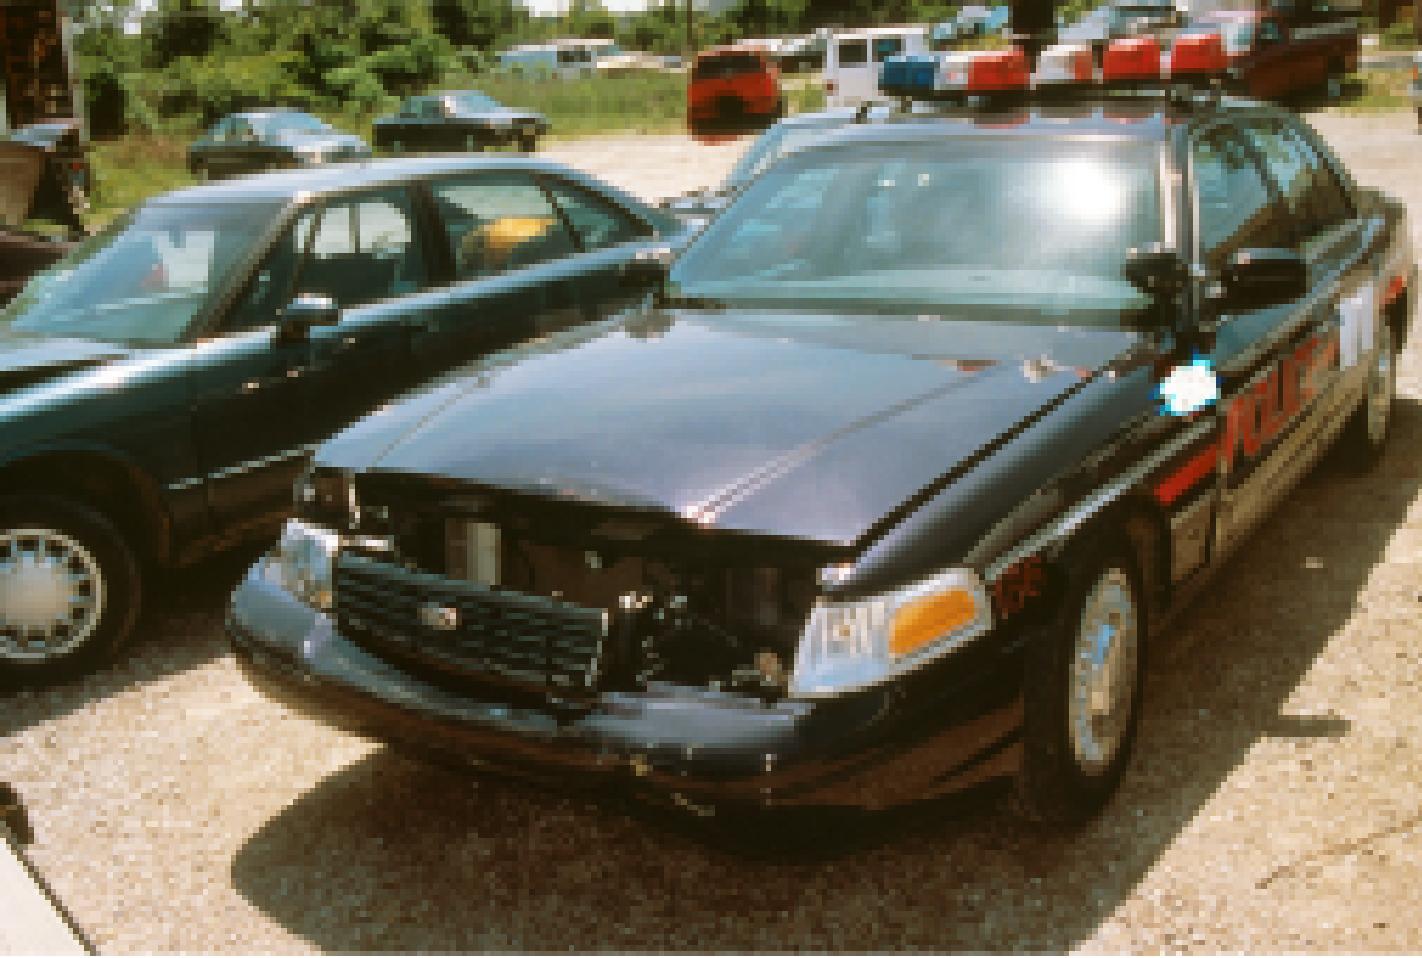
PN 18300 #21

(Slide 21) On the right side, the fender was slightly deformed. Both right-side doors were undamaged and operational. There was no other damage to the right side and no change in the right wheelbase.

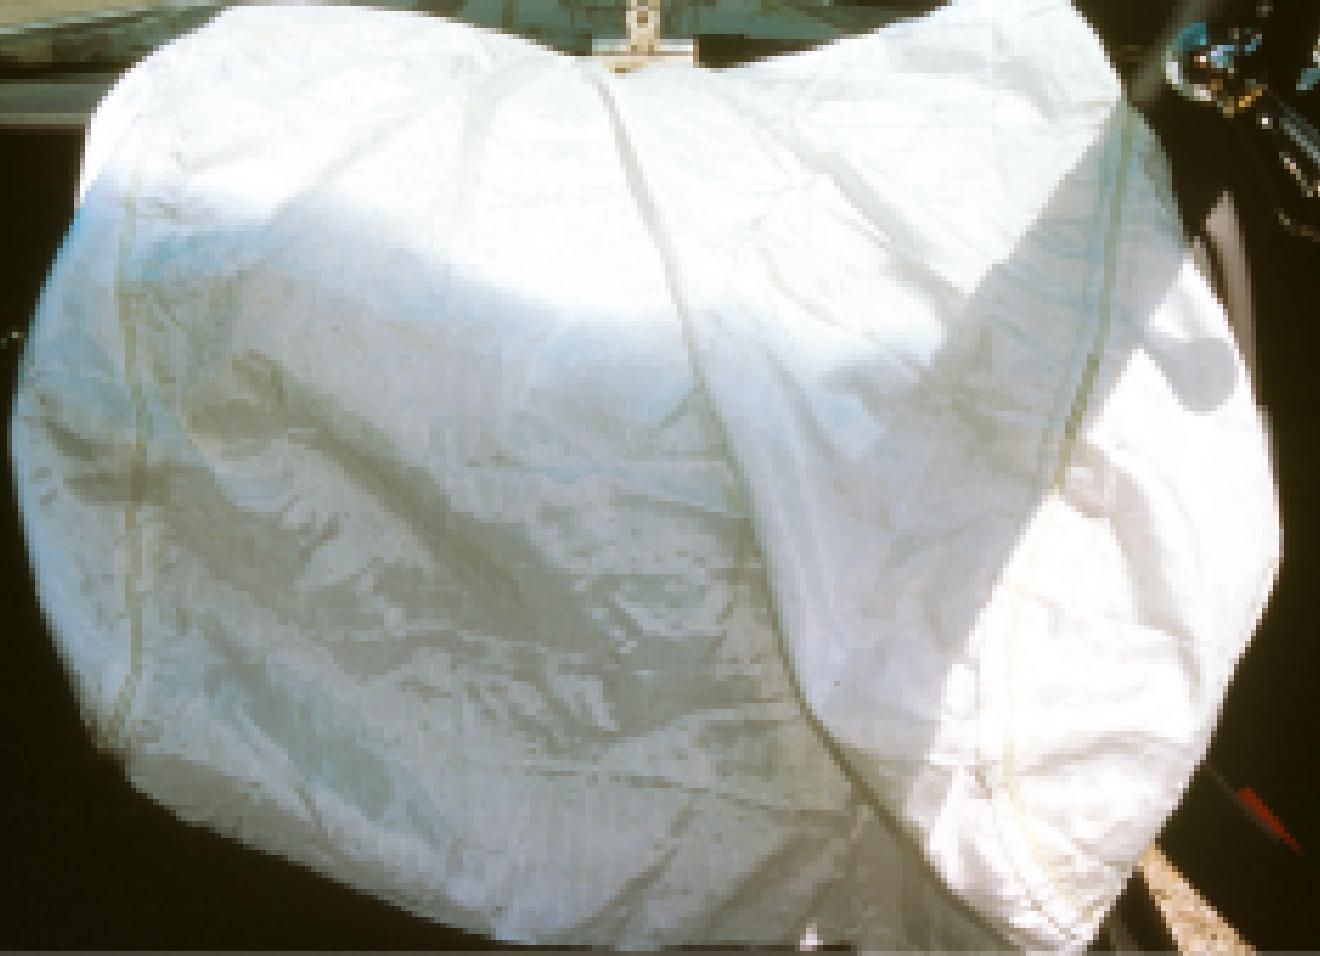
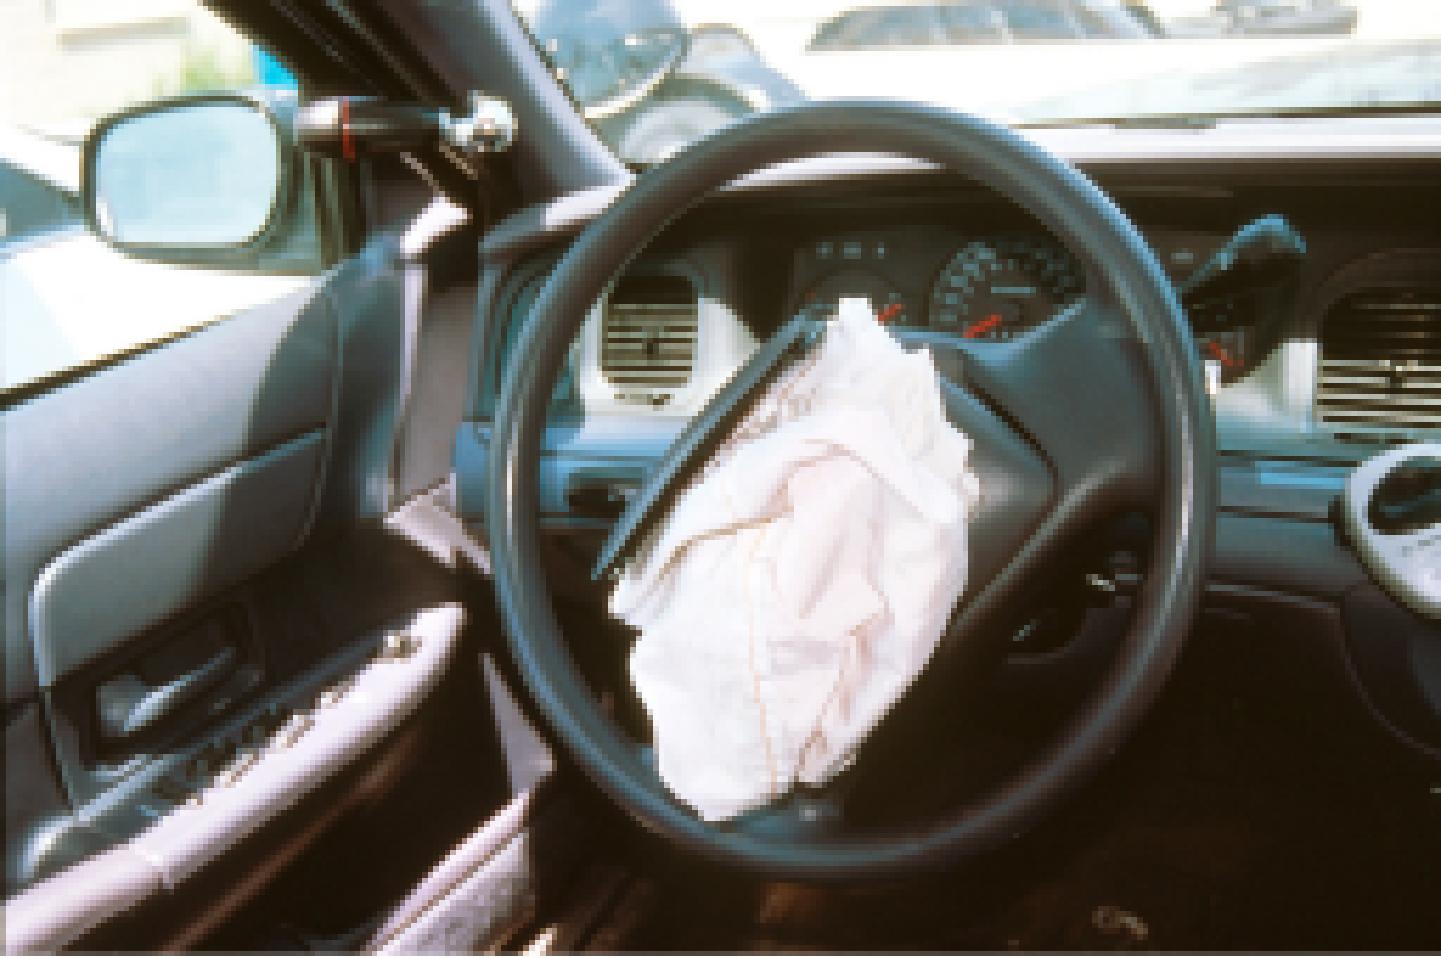
(Slides 23, 24) This vehicle is equipped with steering-wheel and passenger frontal-impact airbags, which deployed during this frontal impact. (Slides 25, 26) There was no damage to the steering-wheel rim and no rotation of the steering column. (Slides 27, 28, 29 and 30) There was no damage to the upper or mid portions of the instrument panel, knee bolster, center dash area, or the glove compartment. (Slides 31, 32) There was no damage to any interior components of this police-modified vehicle and no intrusions were noted.

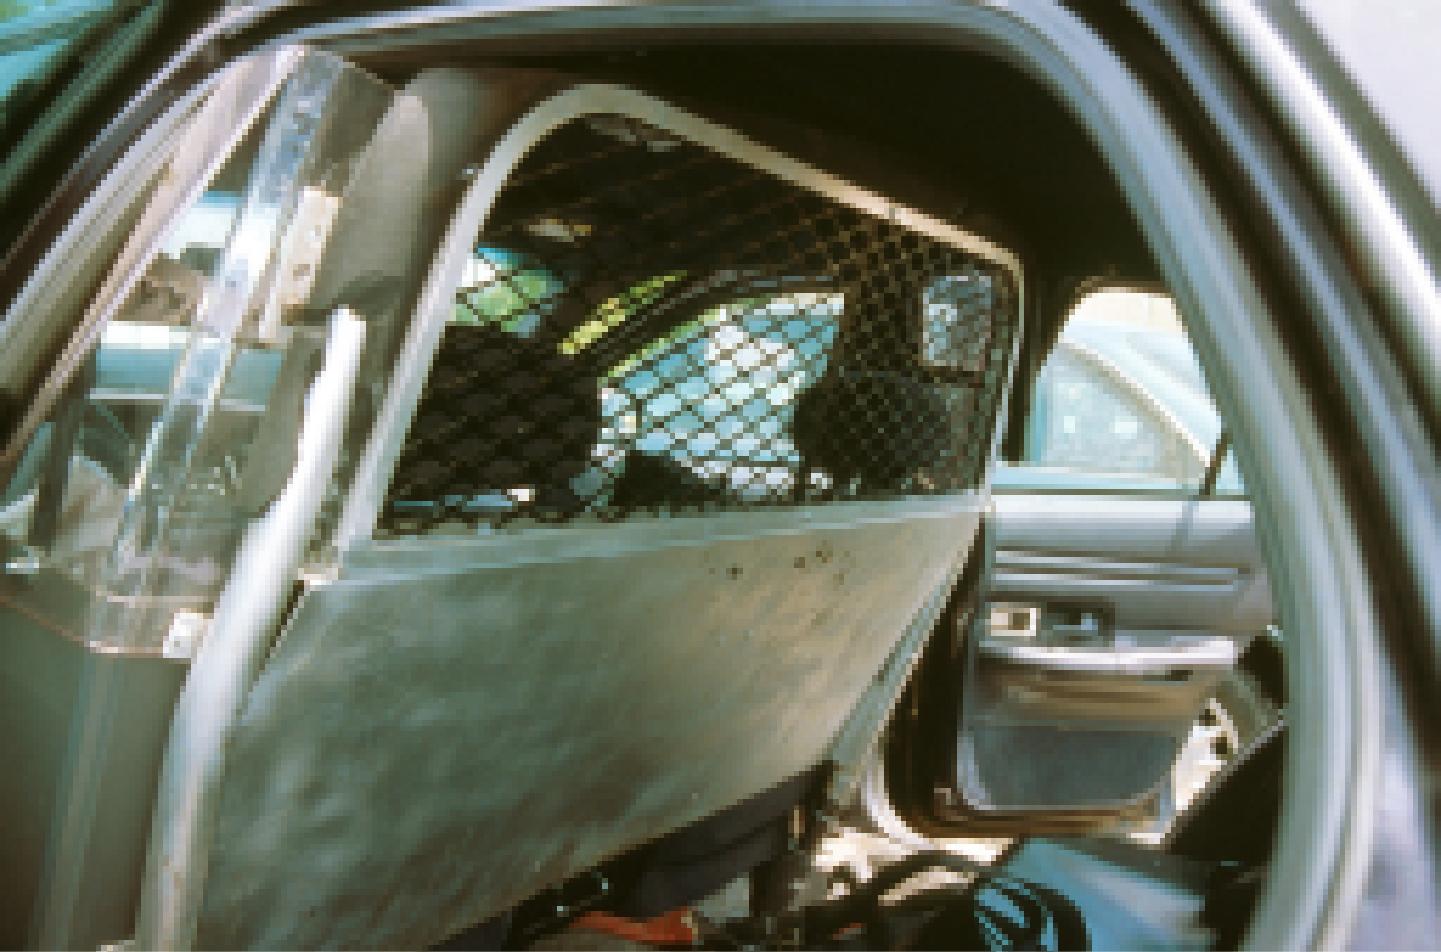
PN 18300-447

(Slides 44, 45 and 46) The 6-ft, 2-in, 245-lb, 23-year-old male right-rear passenger was not wearing the available modified three-point belt system. He was also a police officer but was not wearing a bulletproof vest. (Slides 47, 48) During the frontal impact, he continued forward and slightly to the left relative to the vehicle interior. His face contacted the metal cage that is between the front and rear seats of the police vehicle. He sustained a laceration to the bridge of his nose, a laceration to his right eyebrow, and a laceration to the right side of his forehead, from his face contacting the metal cage.
